Middle Gwynns Falls Small Watershed Action Plan

Volume II

APPENDIX E:
Middle Gwynns Falls Watershed Characterization Report
(PB 2013)

Middle Gwynns Falls Watershed Characterization Report

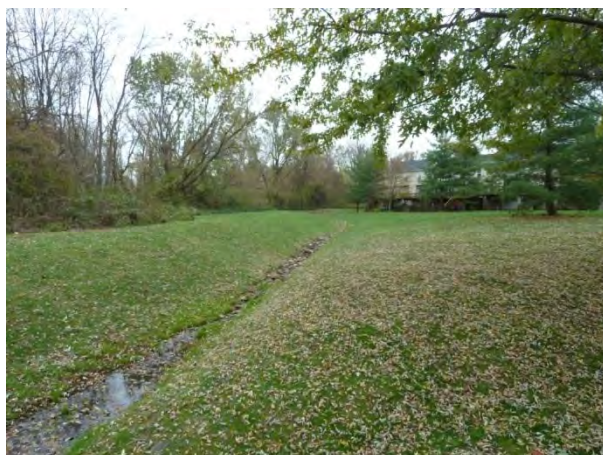
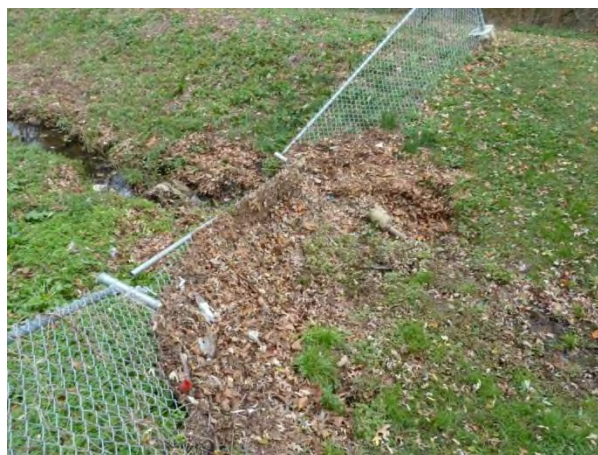
Figure 3-16: Channelized Grass Inflow (left) and Damaged Fence (right) at SWM_C_334

- Replace the existing, inflowing V-ditch with trapezoidal grass channel that could serve as a bioswale.
- Construct pretreatment forebays at the existing pipe outfalls draining to pond.
- The existing low-flow channel in the pond could be converted into a grass swale to provide water quality treatment for smaller storms which contain the majority of pollutants from the drainage area.

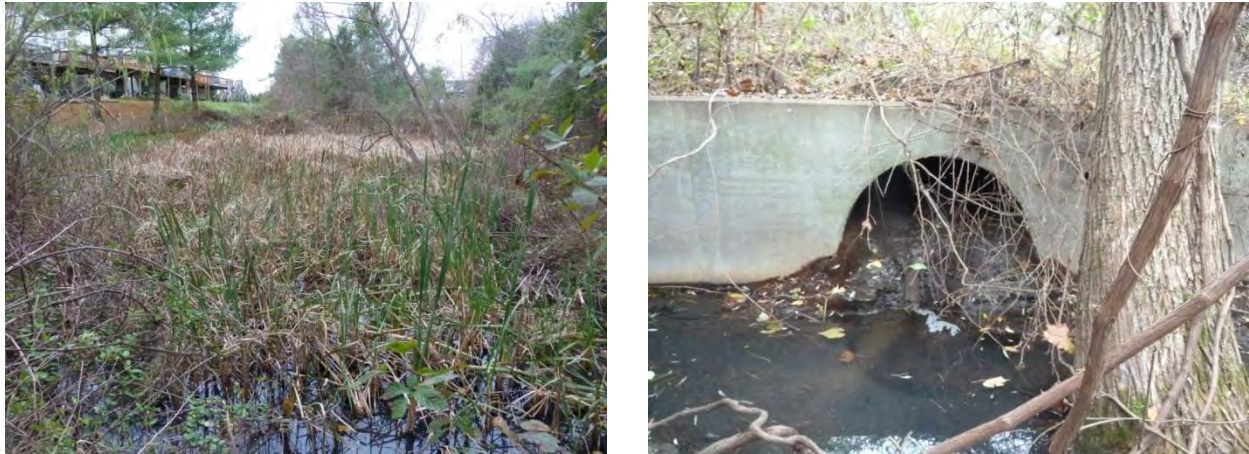
Figure-3-17: Invasive Species, Ponding (left) and Sediment Blocking the Downstream Outfall (right) at SWM_C_432

- Construct pretreatment forebay at the pond inflow channel.
- Construct maintenance access road to the riser.
- Extend the flow path from the inflow to the outfall by constructing concrete baffle wall and/or berms on the pond bottom.
- The large area of the pond provides potential retrofit possibilities including installation of pretreatment forebay at pond inflow channel that could flow into shallow wetlands and then into a deep micropool in front of riser with submerged reverse slope low flow pipe. Because of the current blockage at the pipe outfall, the pond is performing similarly to a stormwater wetland facility. If flooding during larger events has not been an issue, there is the potential for the pond to be permanently converted to a stormwater wetland facility.

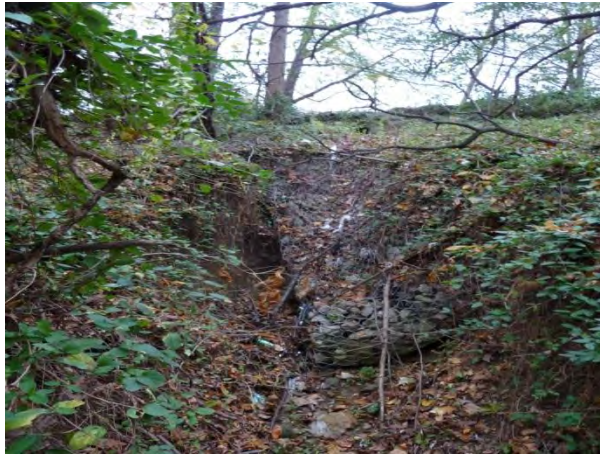
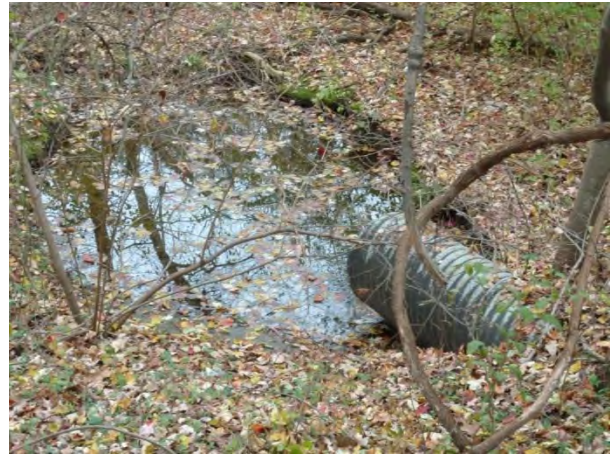
Figure-3-19: Side Slope Failure (left) and Erosion & Undercutting at Outfall (right) at SWM_C_450

- Stabilize the pond side slopes to prevent the erosion.
- Repair erosion around the riser.
- Stabilize the gabion structure at pond inflow.
- Construct the riprap outlet protection to prevent the erosion at downstream channel.
- Construct maintenance access roads to the riser and pond inflow.

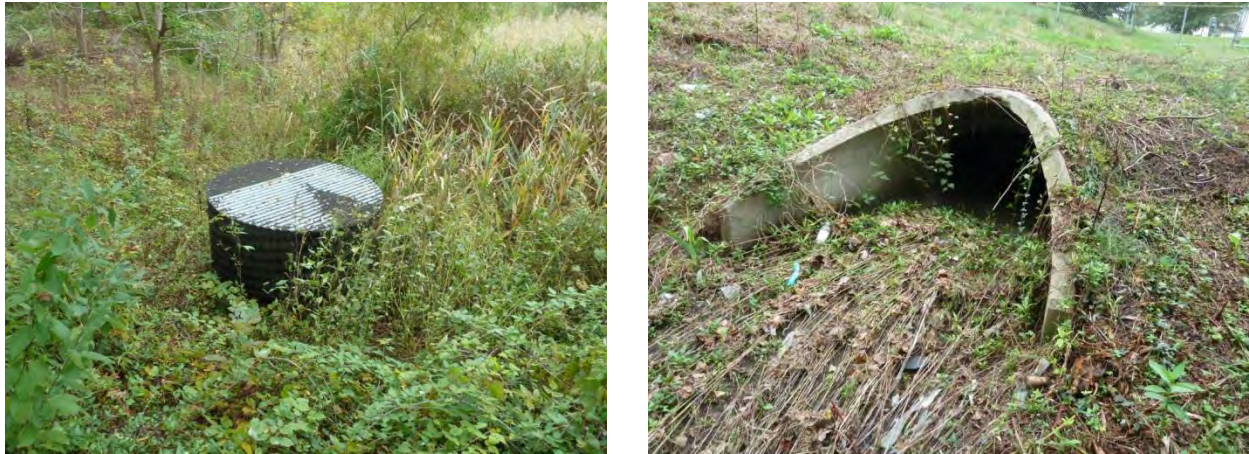
Figure -3-20: Outlet Structure (left) and Sediment at Inflow (right) at SWM_C_651

- Remove trees from the pond embankment and bottom.
- Invasive species management
- Unclog existing inflow filled with sediment from the inlet at Lawnwood Circle draining to the pond.
- Construct the riprap outlet protection at the pipe outfall draining into pond.

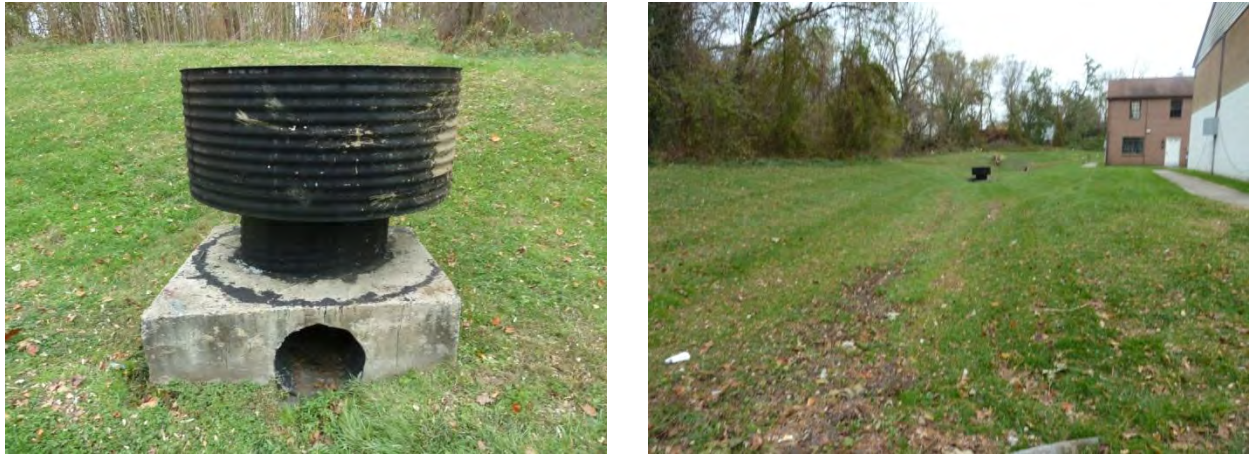
Figure-3-21: Riser with 18" Low Flow Pipe (left) and Grass Swale Leading to Riser (right) at SWM_C_715

- Construct a micropool at pond inflow channel.
- If the pond has adequate capacity, the 18" low flow orifice of the riser structure should be altered in order to detain water for a 24 hour detention time, which is the current standards for extended detention ponds in Use I waters.

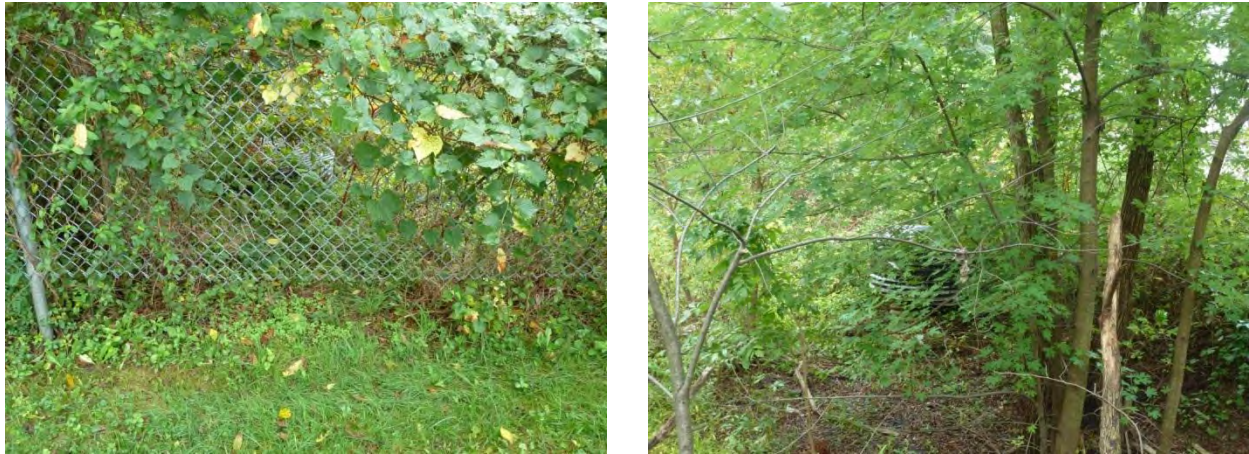
Figure-3-22: Fence Not Extended to Ground (left) and Vegetation Around Riser (right) at SWM_C_738

- The fence should be repaired to prevent access to the riser structure as well as being cleared of vegetation and vines.
- Remove trees threatening the stability of the pond embankment and at pond bottom.
- The pond bottom can be cleaned and the inflow channel upgraded to provide long detention times and potential evapotranspiration to low flows.

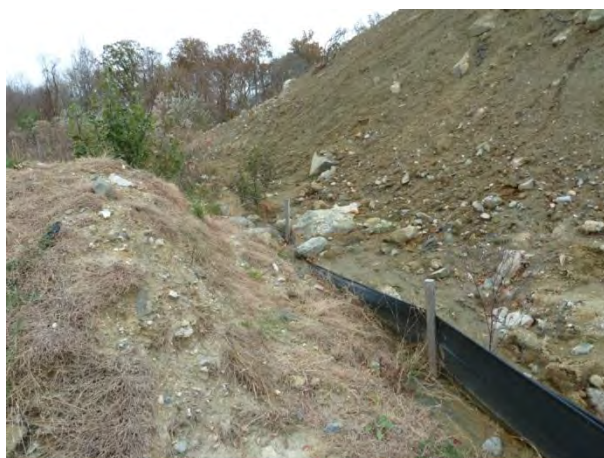
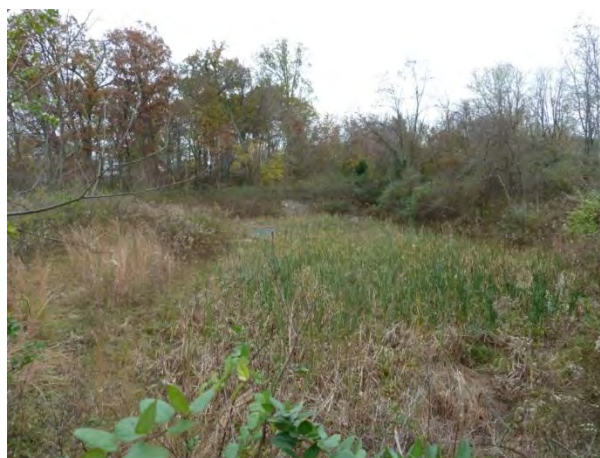
Figure-3-23: Sediment from Adjacent Stockpile Overtopping Silt Fence (left) and Dense Vegetation around Riser (right) at SWM_C_817

- Invasive species management.
- Clear vegetation and vines at fence.
- Remove trees threatening the stability of the pond embankment.
- Construct maintenance access road to the riser, pond inflow.
- At the time of the assessment, observations on the poor erosion and sediment control practices were provided to representatives at EPS. It is recommended that the site be inspected regularly to ensure that sediment from the adjacent property does not wash into the pond.

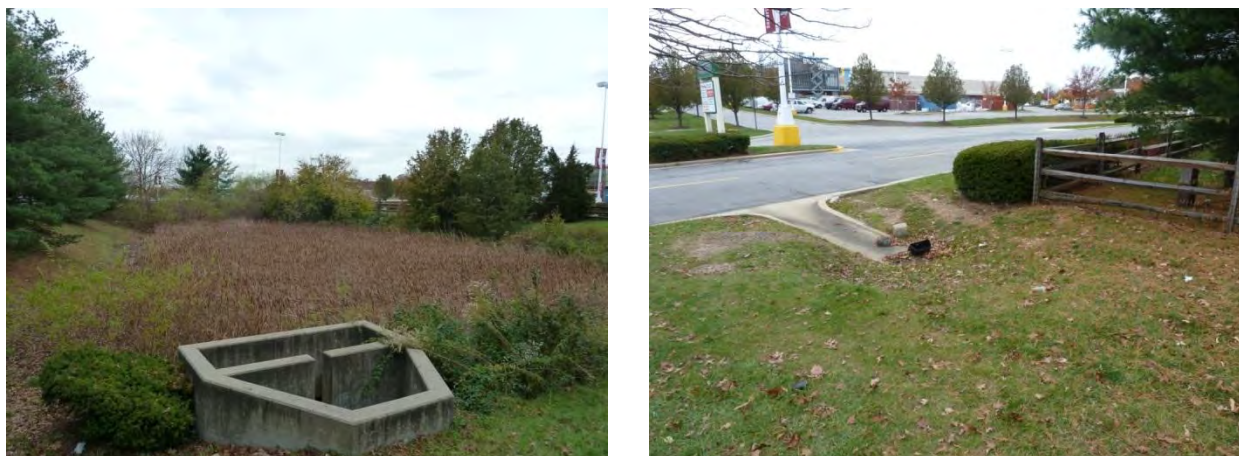
Figure-3-24: Dense Invasive Vegetation Around the Outlet Structure (left) and Curb Cut Inlet Configuration (right) Draining to SWM_C_857

- Construct pretreatment forebay at existing pipe outfall into the pond.
- Extend the pond horizontally to provide additional capacity for conversion to an extended detention facility.

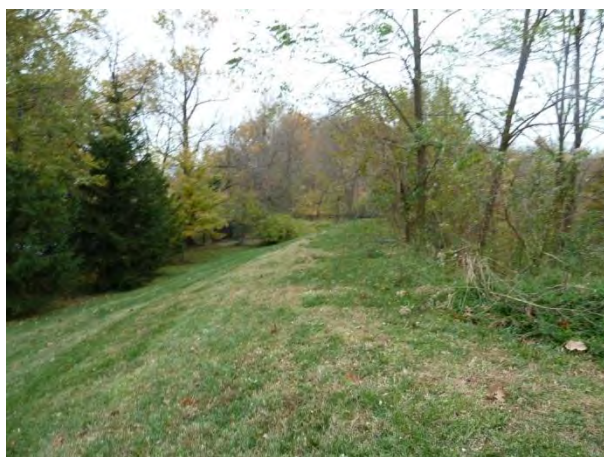
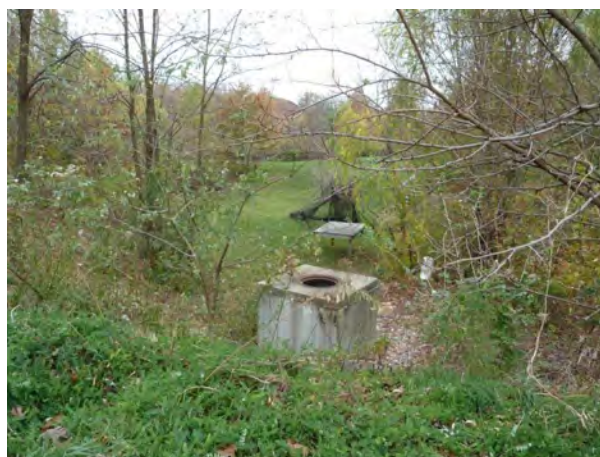
Figure-3-25: Pond Embankment (left) and Control Structure with Missing Lid (right) at Detention Pond SWM_C_859

- Construct a micropool at pond inflow.
- Extend the pond horizontally to provide additional capacity for conversion to an extended detention facility.

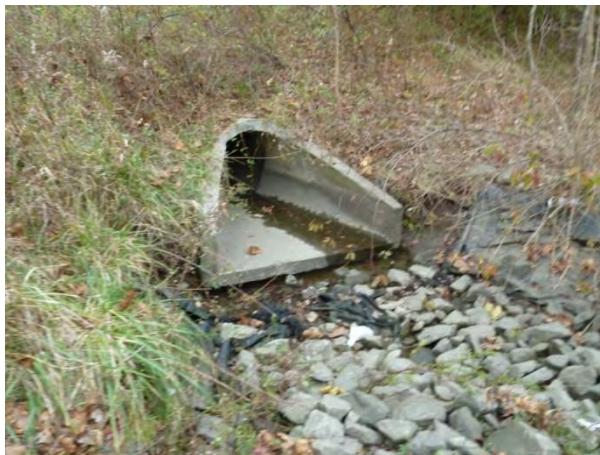
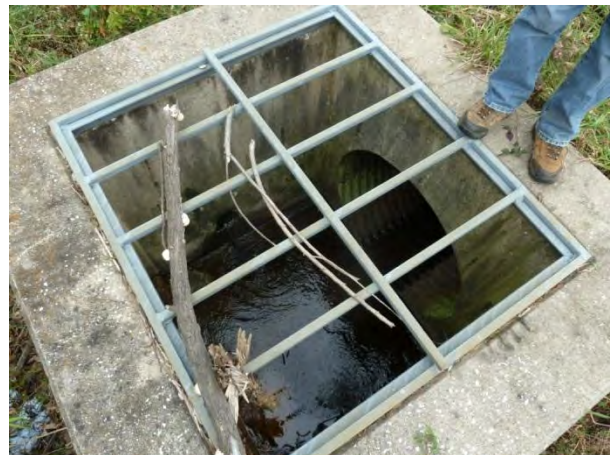
Figure-3-26: Undercutting and Erosion at Inflow Endsection (left) and Control Structure with Flowing Underdrains (right) at SWM_C_961

- Construct a micropool at pond inflow.
- Extend the pond horizontally to provide additional capacity for conversion to an extended detention facility.

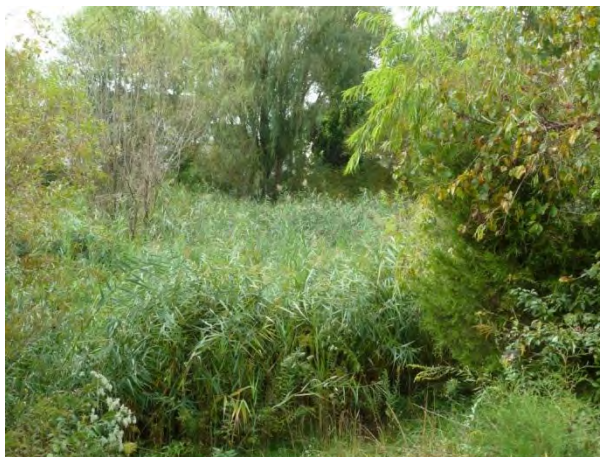
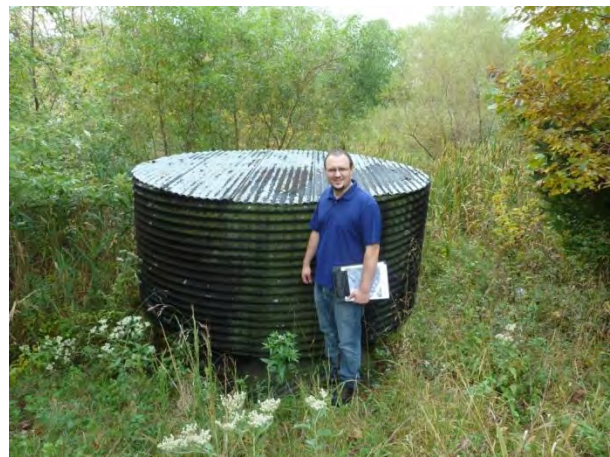
Figure-3-27: Invasive Species (left) and Control Structure (right) at SWM_C_967

- The large area of the pond provides potential retrofit possibilities including installation of pretreatment forebay at pond inflow channel that could flow into shallow wetlands and then into a deep micropool in front of riser with submerged reverse slope low flow pipe.
- The low flow channel could be upgraded to remove the invasive species.

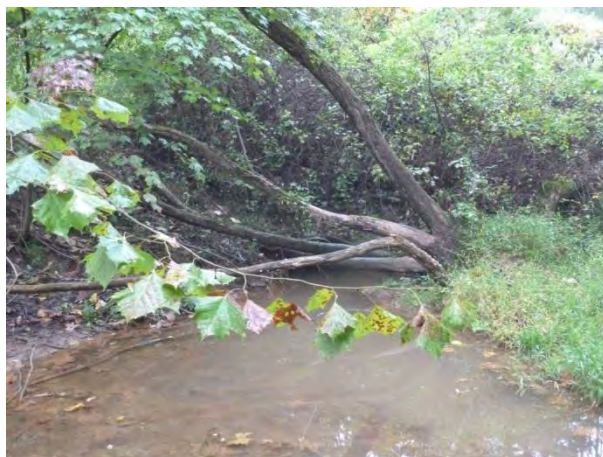
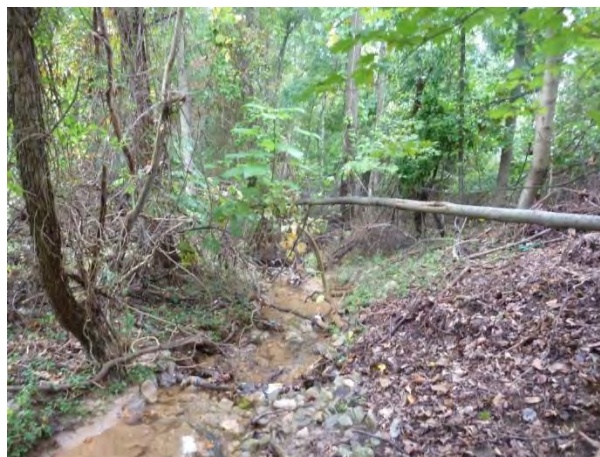
Figure-3-28: Down Tree Branches at Pond Outfall (left) and Low Flow Channel (right) at SWM_C_984

- The flow path could be lengthened by constructing a meandering channel.
- Construct maintenance access road to the riser.
- The large area of the pond provides potential retrofit possibilities including installation of pretreatment forebay at pond inflow channel that could flow into shallow wetlands or wet detention pond and then into a deep micropool in front of riser with submerged reverse slope low flow pipe.
- The capacity of the pond should be determined to verify if there is potential for conversion to an extended detention facility.

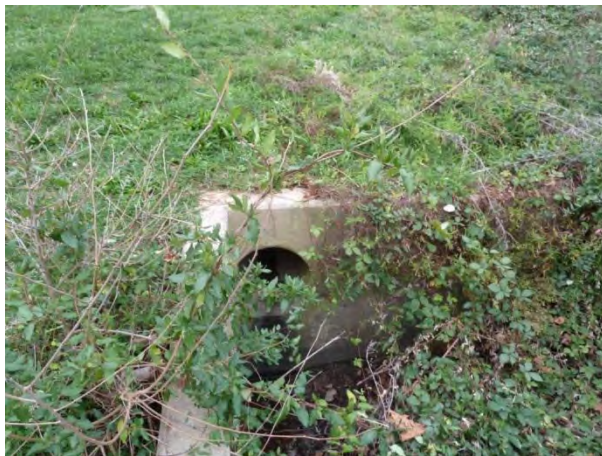
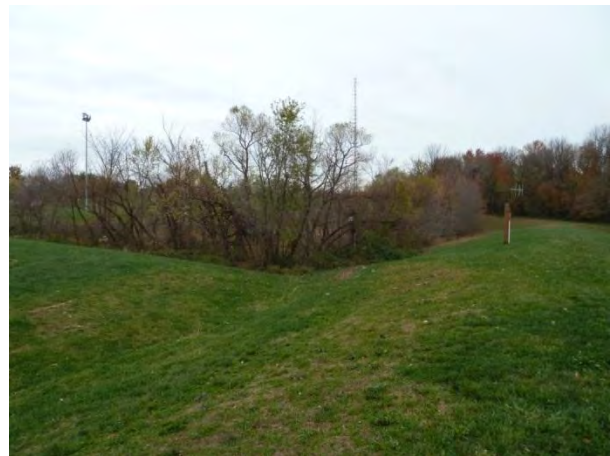
Figure-3-29: Pipe Invert at Inflow Endwall above Grade (left) and Wide Grass Swale Draining to Pond (right) at SWM_C_1188

- Construct a micropool at pipe inflow and inflow channels.
- Convert the 3 grassed swales flowing into the pond into bioswales to treat runoff.

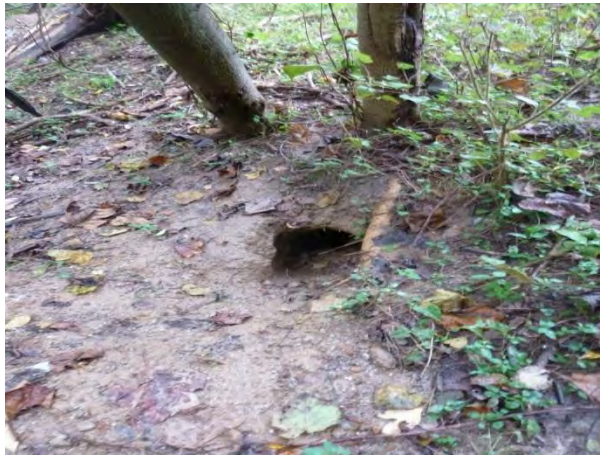
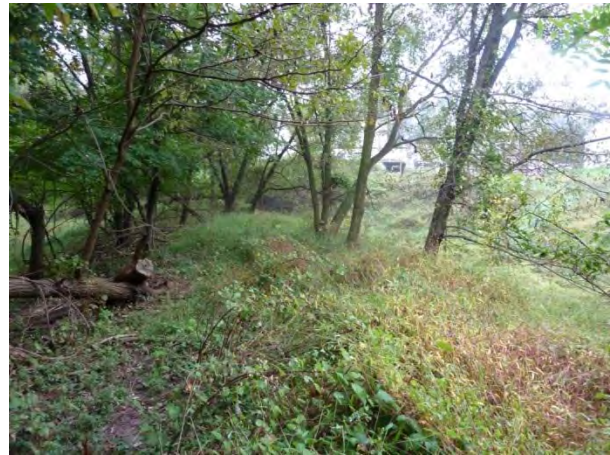
Figure-3-30: Animal Burrow (left) and Trees (right) on the Embankment at SWM_C_1652

- Remove small trees from the pond bottom.
- Remove trees and fill animal burrows threatening the stability of the pond embankment.

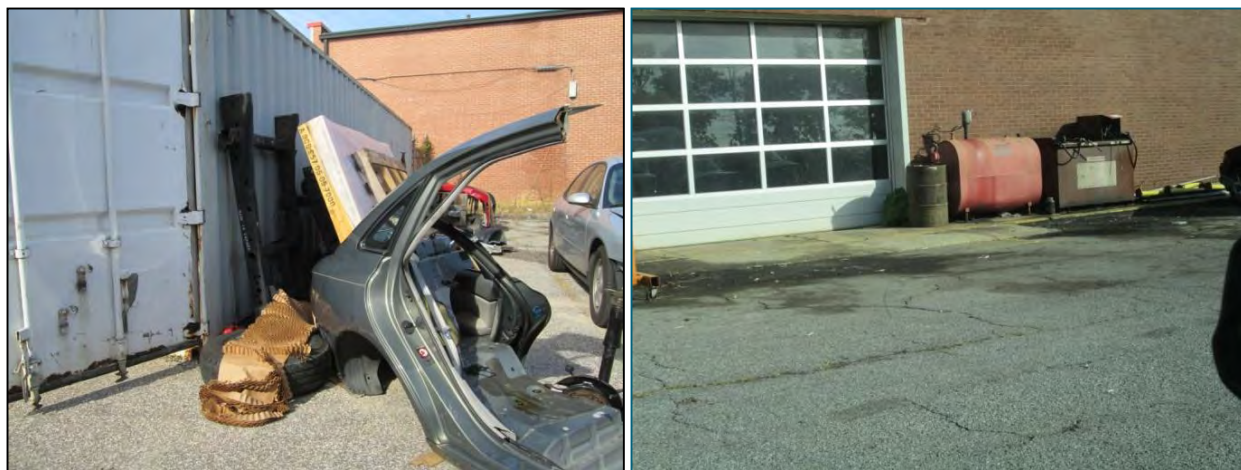
Figure 4-12: Potential Pollution Sources from Outdoor Material Storage at Auto-related Hotspots including uncovered materials stored outside (left) and storage containers without secondary containment (right).

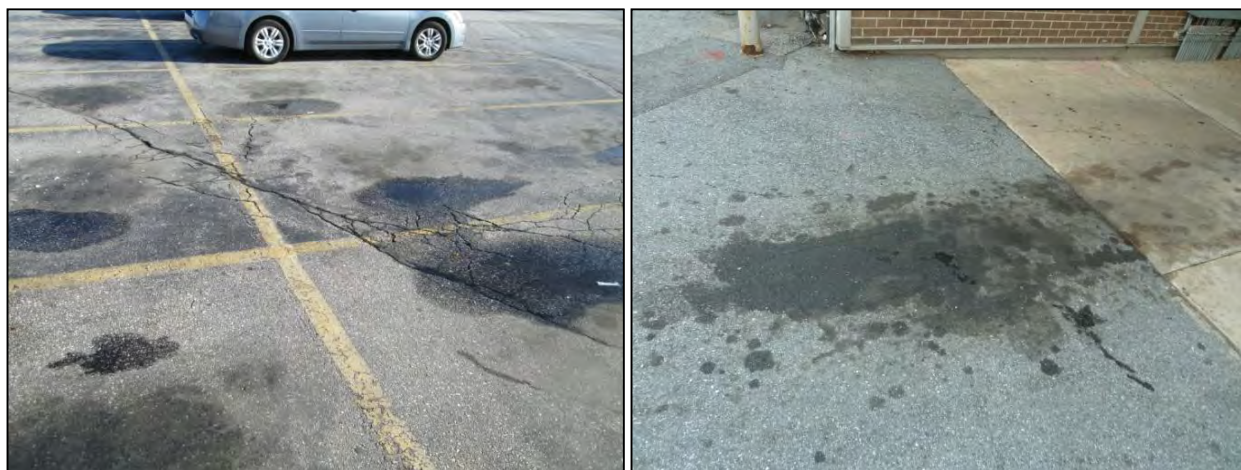
Figure 4-13: Asphalt staining from Outdoor Vehicle Operations at Auto-related Hotspots.

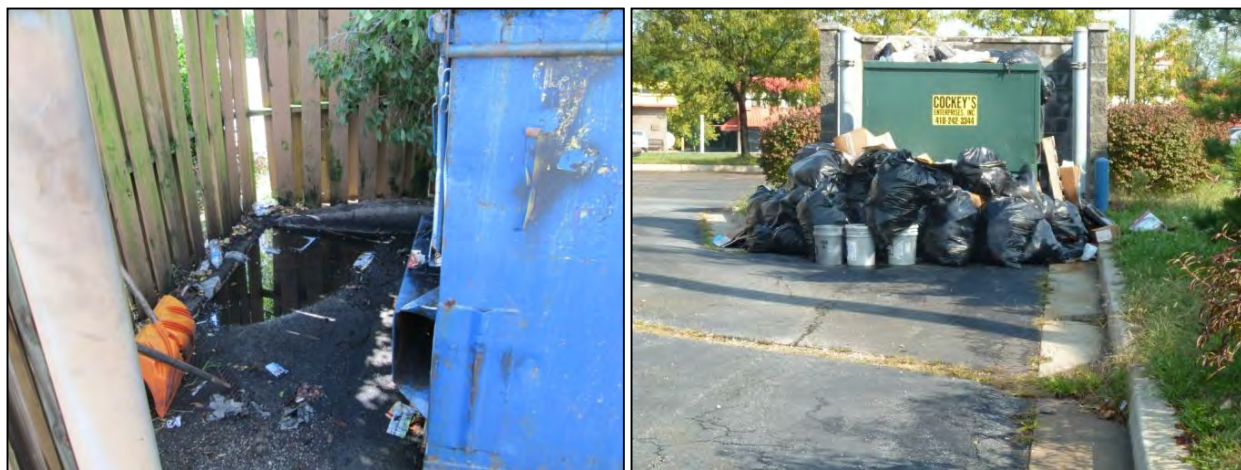
Figure 4-14: Leaking (left) and Overflowing Dumpsters (right) from Waste Management Operations at Auto-related Hotspots

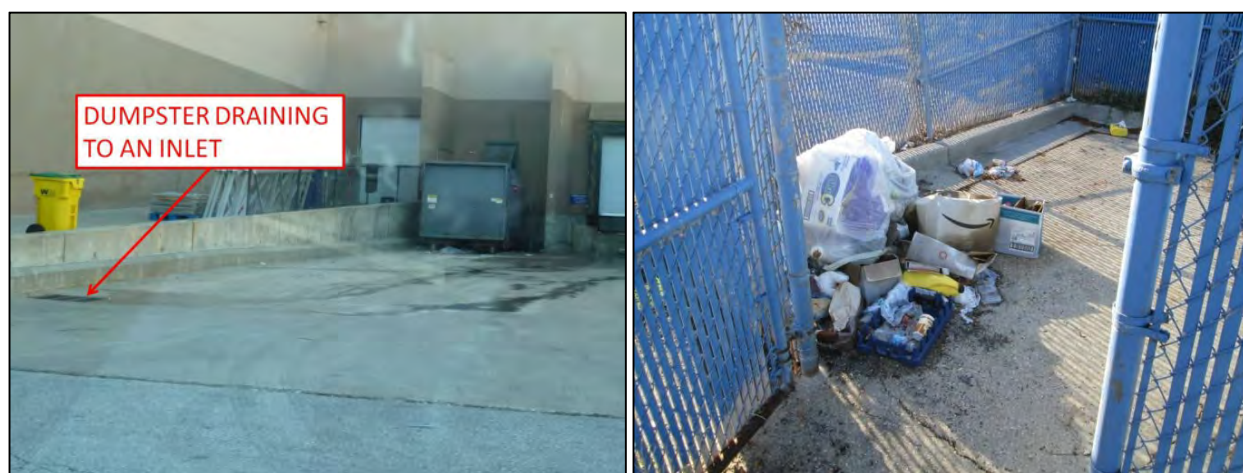
Figure 4-15: Leaking (left) and Overflowing Dumpsters (right) from Waste Management Operations at Commercial Hotspots

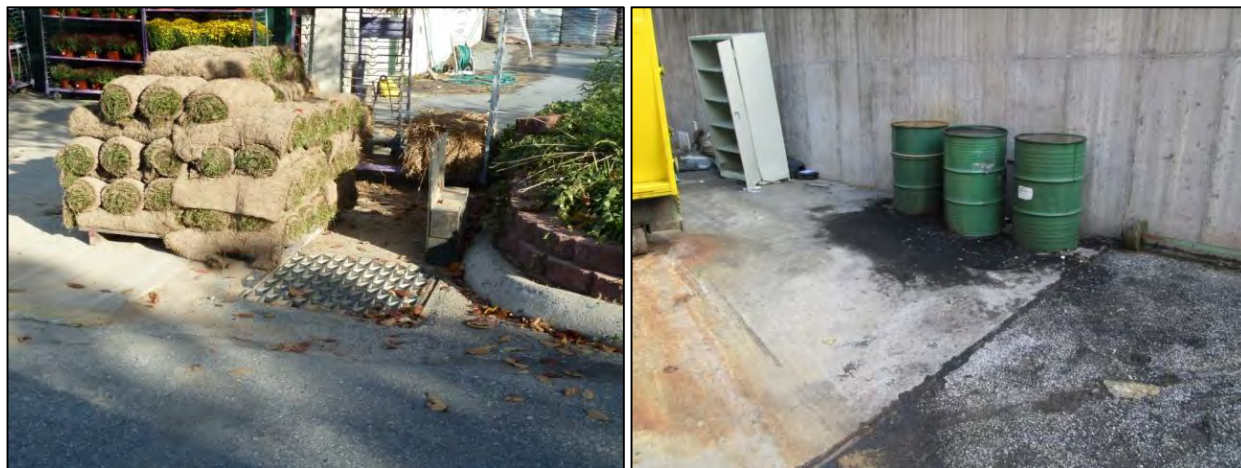
Figure 4-16: Outdoor Material Storage at a Garden Center (left) and a Hardware Store (right).

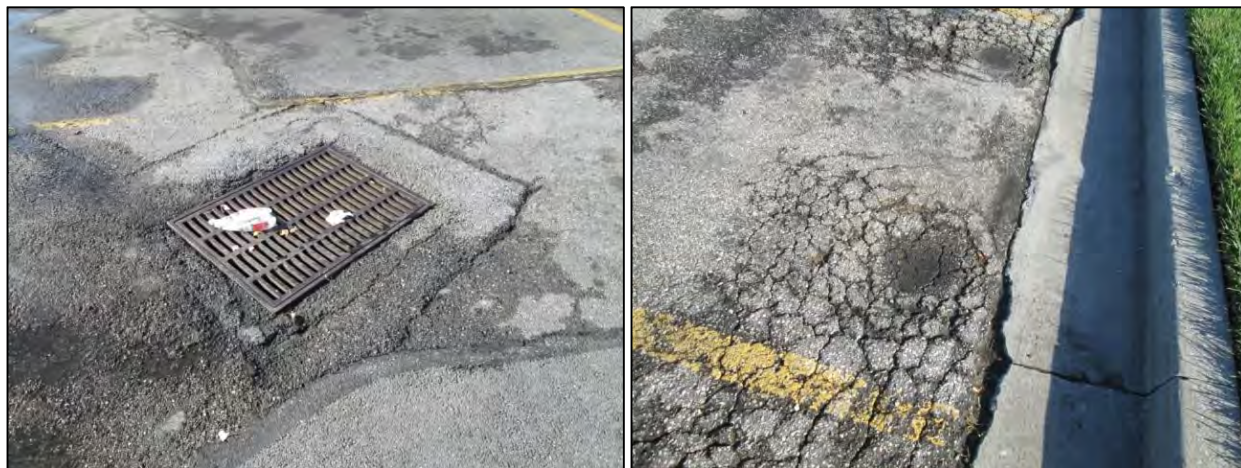
Figure 4-18: Degraded Impervious Surfaces at Commercial Hotspots

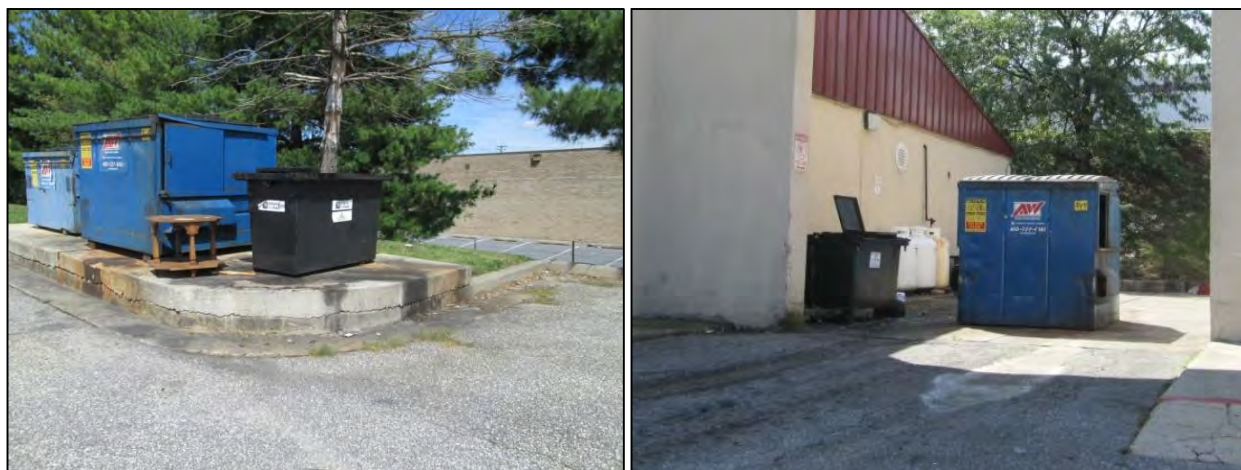
Figure 4-20: Leaking Grease Bins from Waste Management Operations at Restaurant Hotspots

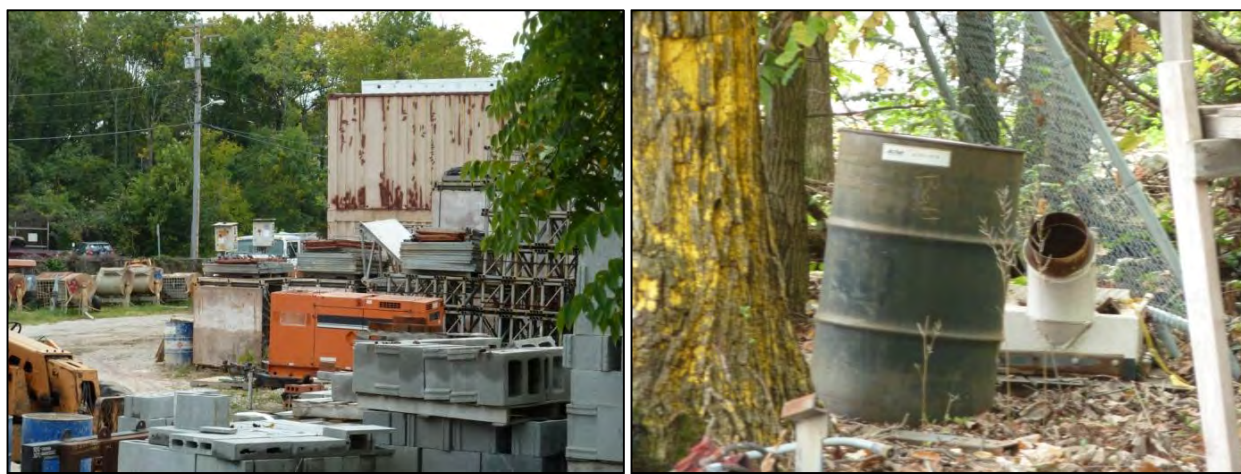
Figure 4-22: Improper Outdoor Materials Storage at Industrial Hotspots

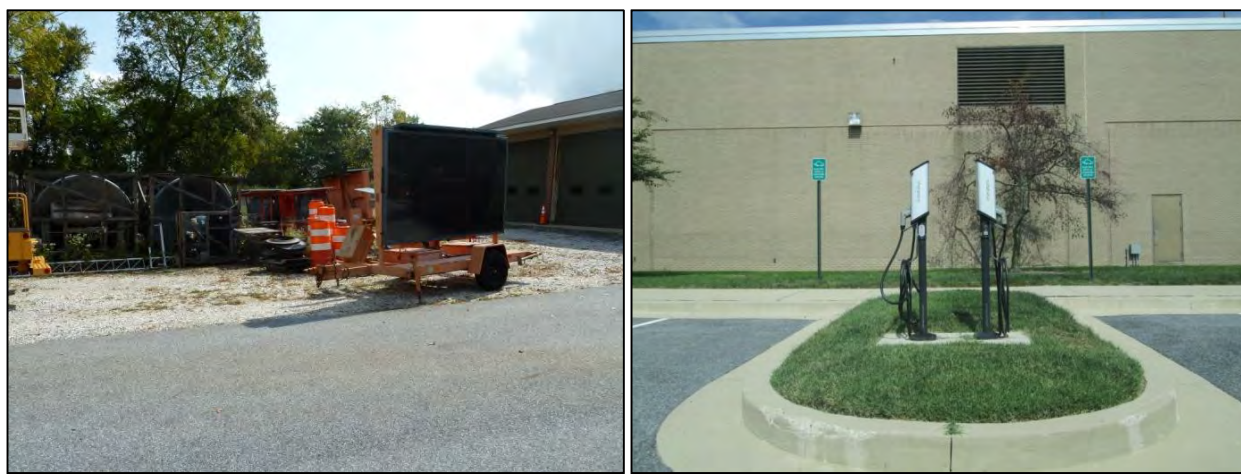
Figure 4-23: Equipment Storage on Pervious Areas (left) and an Electric Vehicle Charging Station (right) at Municipal Hotspots

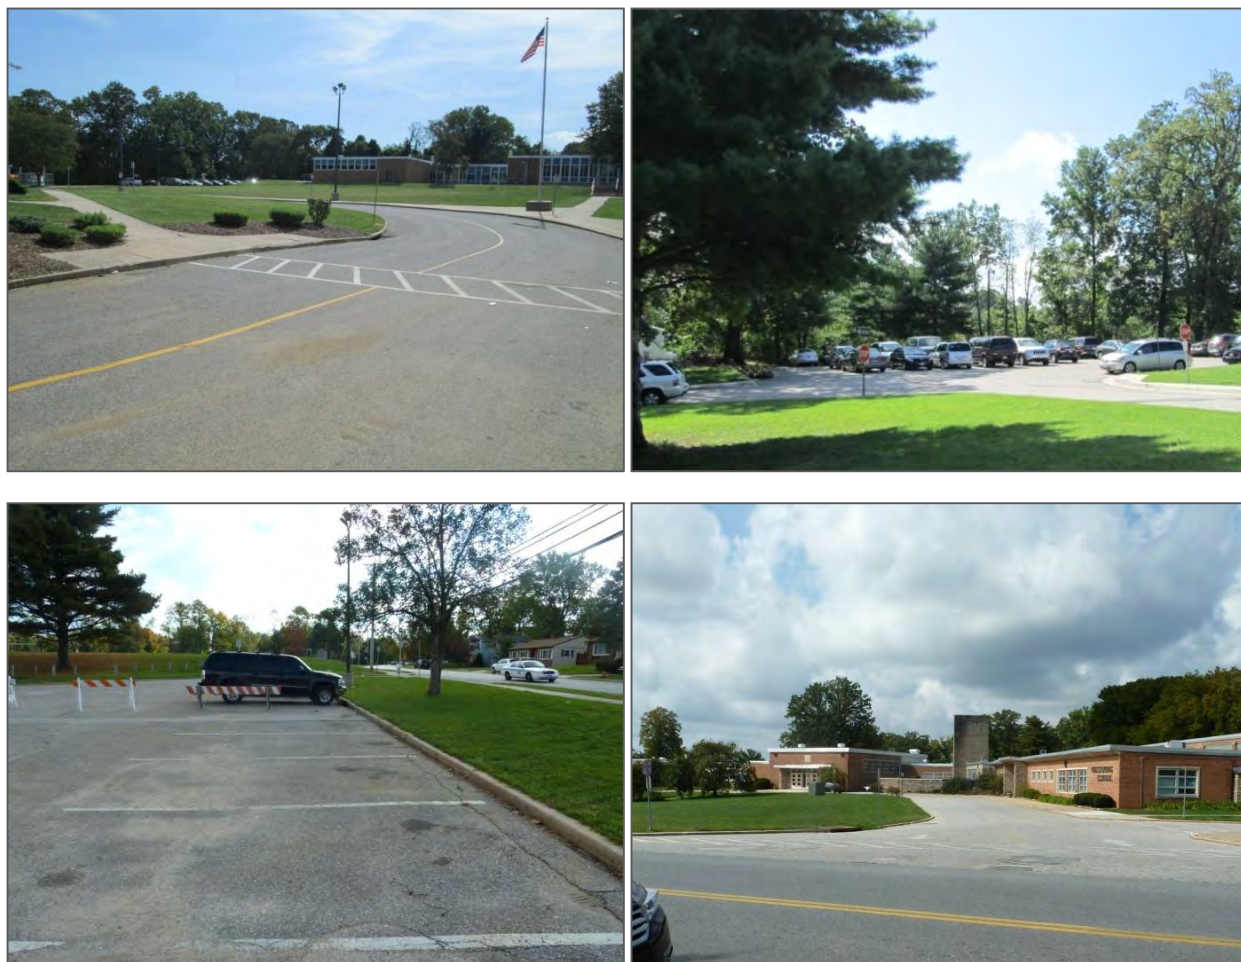
Figure 4-25: Parking Lot Retrofit Opportunities at ISI_C_117 (top left), ISI_C_202 (top right), ISI_C_306 (bottom left) and ISI_C_401 (bottom right)

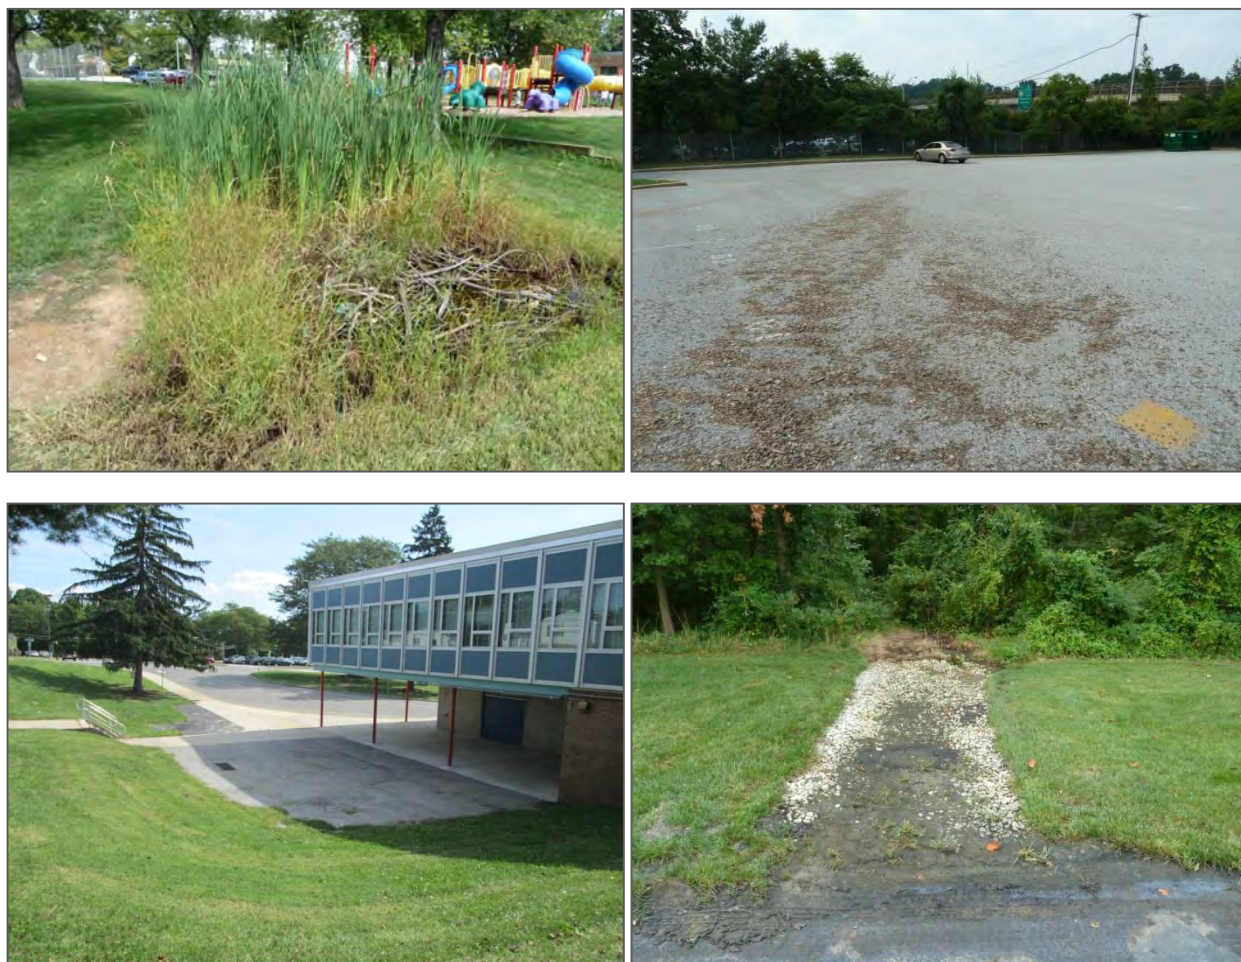
Figure 4-26: Various Retrofit Opportunities such as a level spreader at ISI_C_104 (top left), a microbioretention at ISI_C_108 (top right), a microbioretention at ISI_C_117 (bottom left) and wet swale at ISI_C_201 (bottom right)

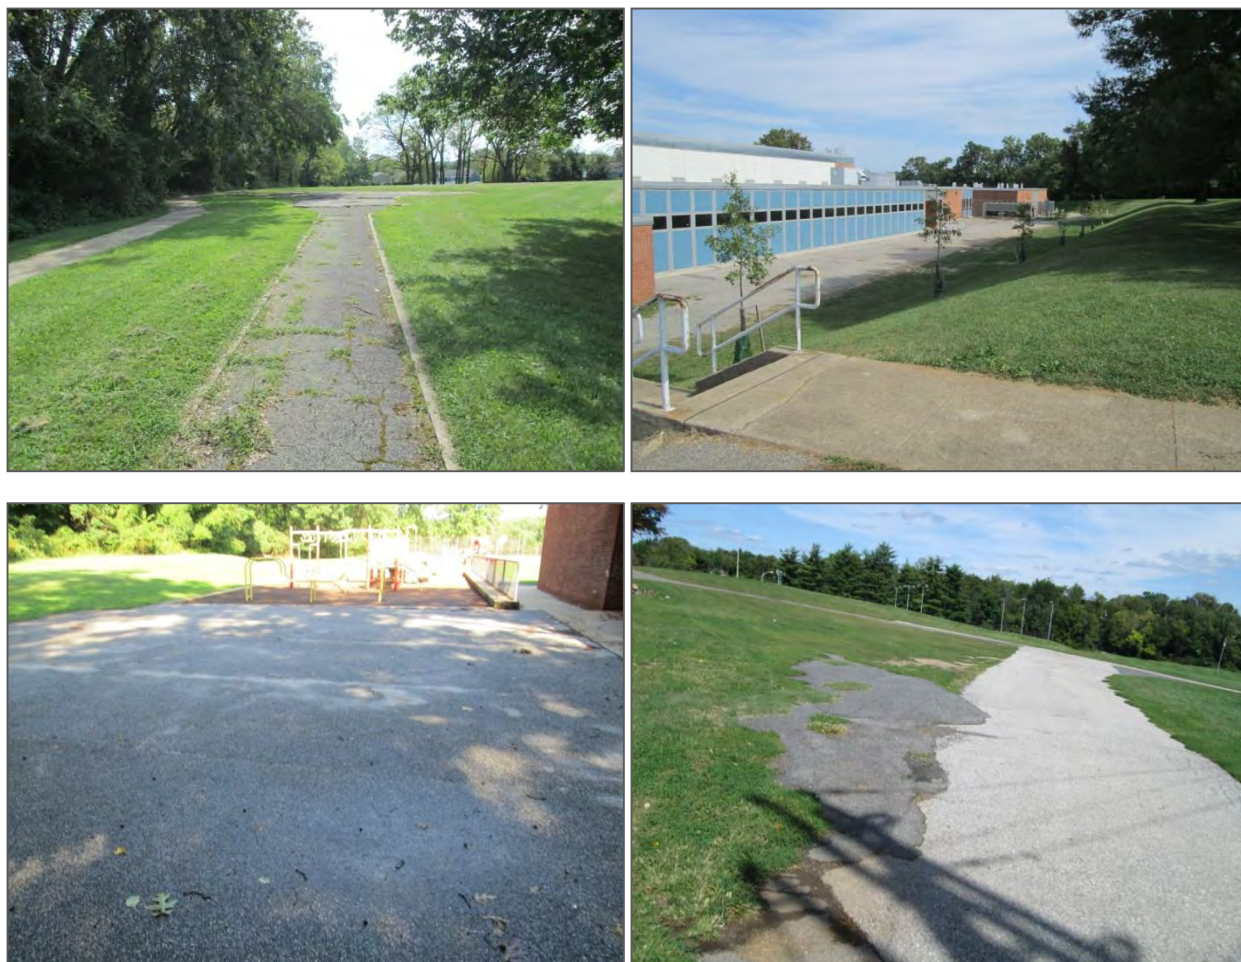
Figure 4-27: Extraneous Asphalt Cover Removal Opportunities at ISI_C_117 (top left and top right), ISI_C_202 (bottom left), and ISI_C_304 (bottom right)

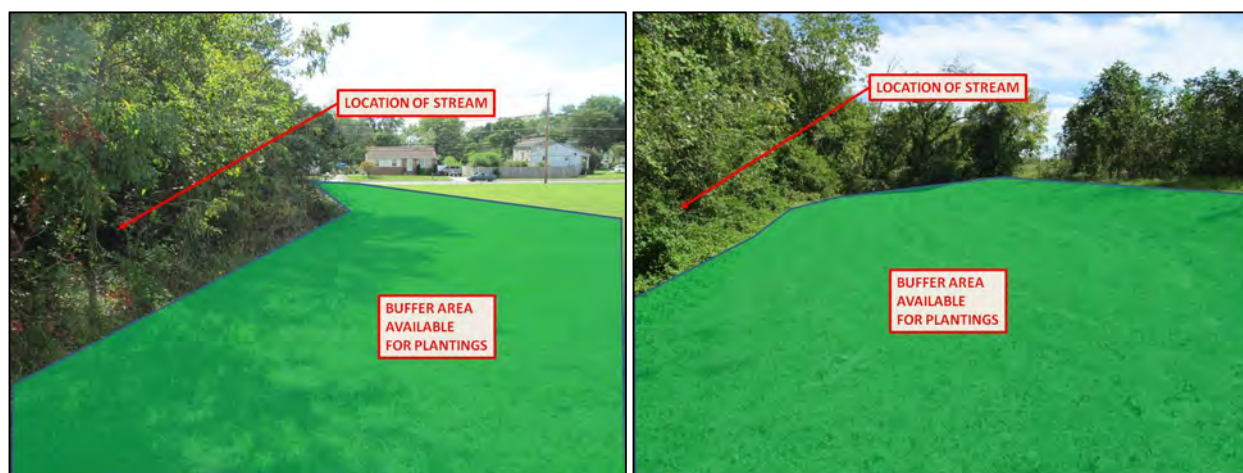
Figure 4-29: Buffer Improvement Opportunity at ISI_C_0302 (left) and ISI_C_0304 (right)

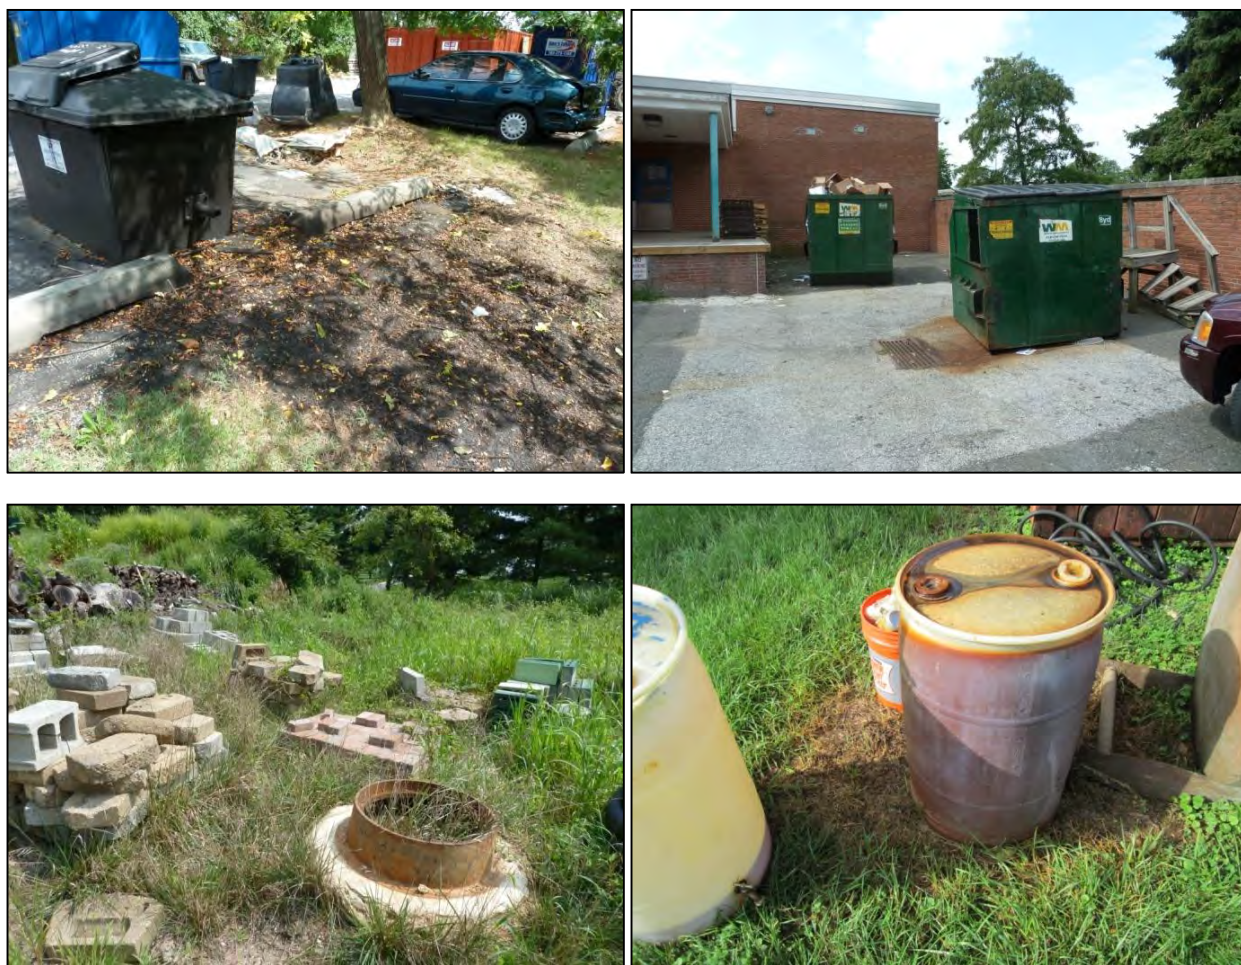
Figure 4-30: Trash Management Opportunities at ISI_C_103 (top left), ISI_C_105 (top right), ISI_C_102 (bottom left), ISI_C_113 (bottom right).

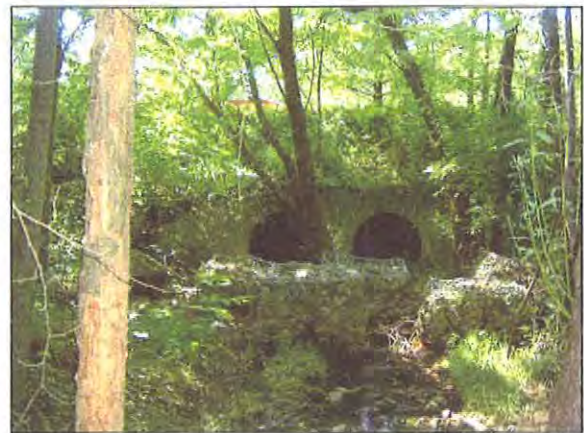
Looking upstream at outfall and failed dissipators
(Summer 2003)

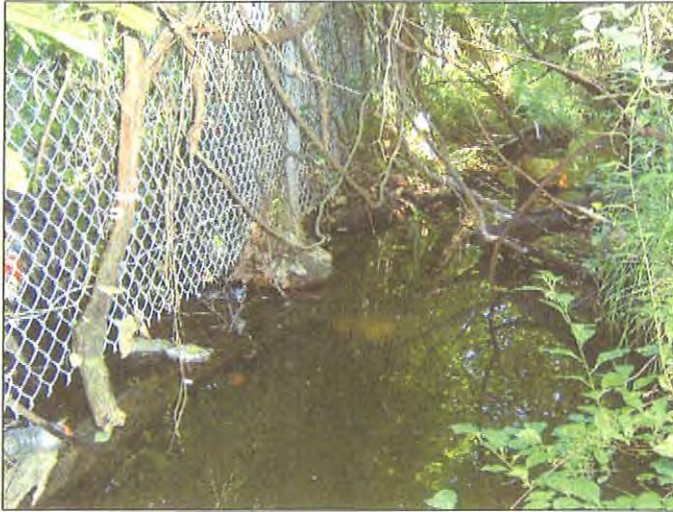
Downstream channel along I-695 right of way fence (Summer 2003)
